FIRST FLOOR PLAN AS-BUILT/DEMO PLAN

SECOND FLOOR PLAN

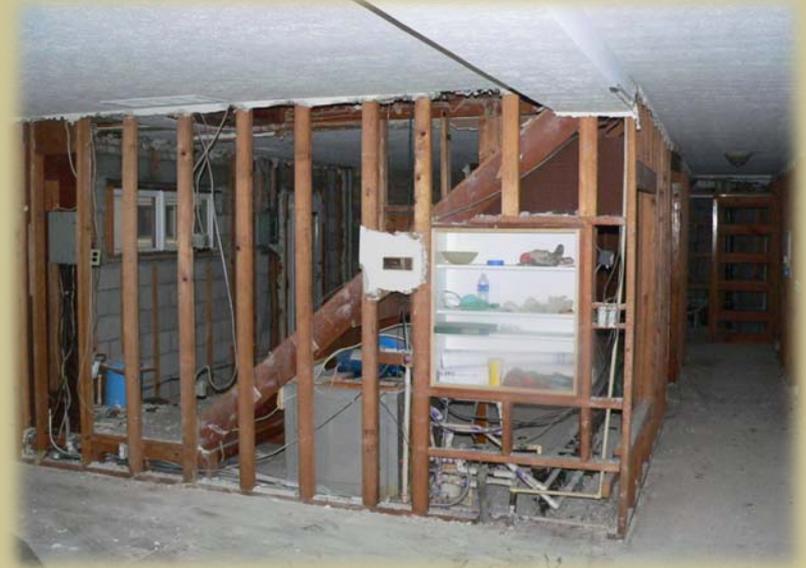
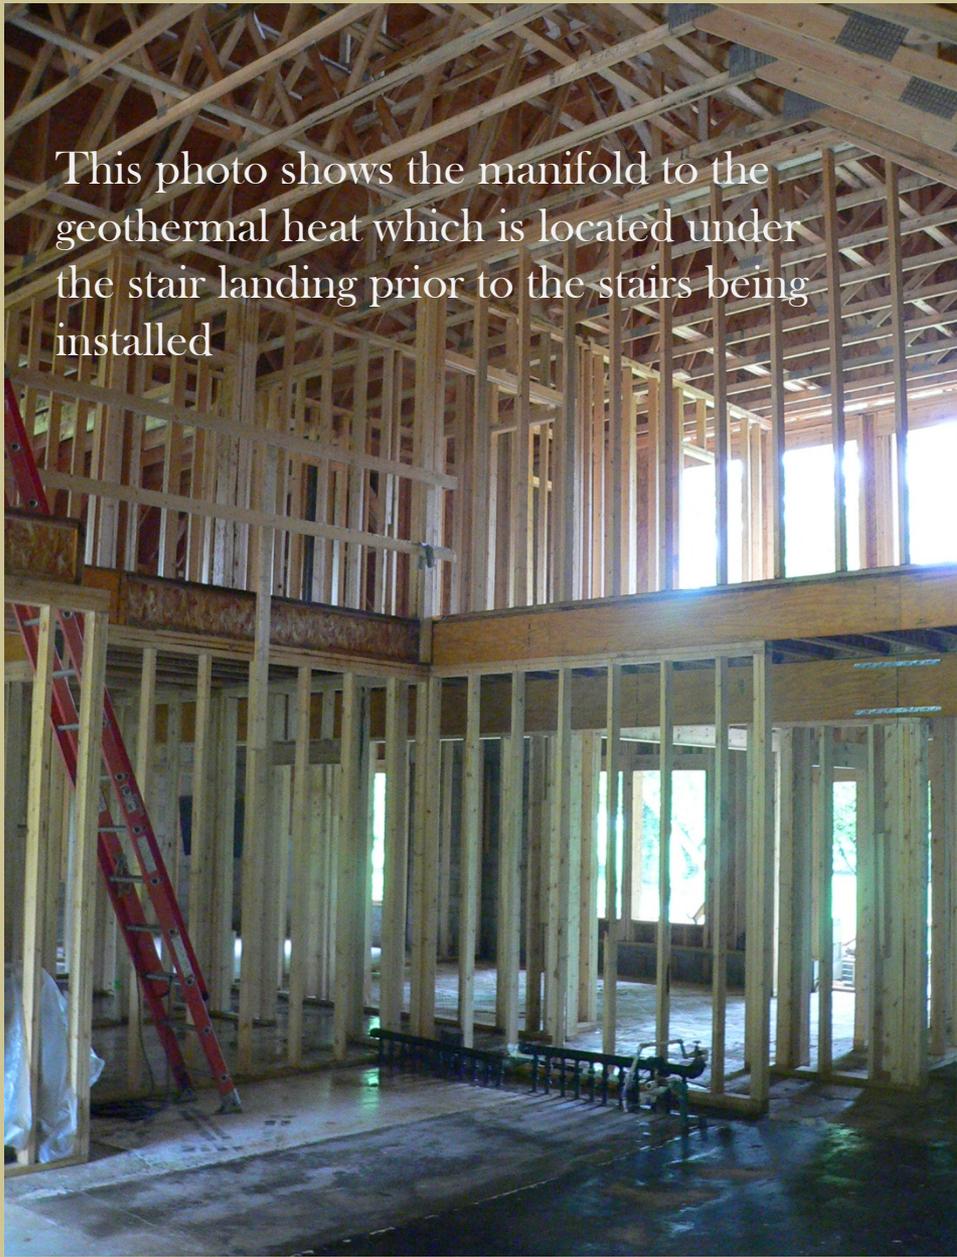
This photo shows the manifold to the geothermal heat which is located under the stair landing prior to the stairs being installed

The location of the existing manifold for the geo-thermal radiant floor heat was a critical factor in the design of the first floor and location of the stair landing.

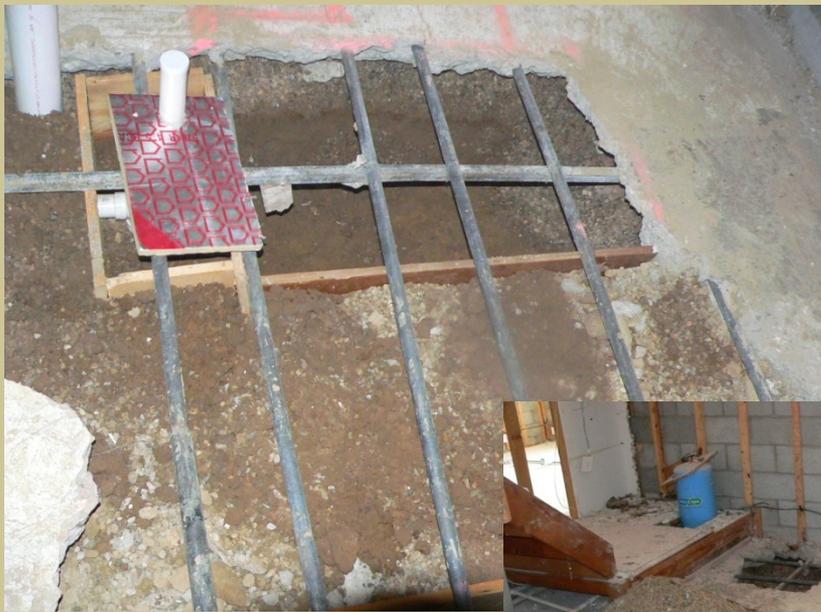
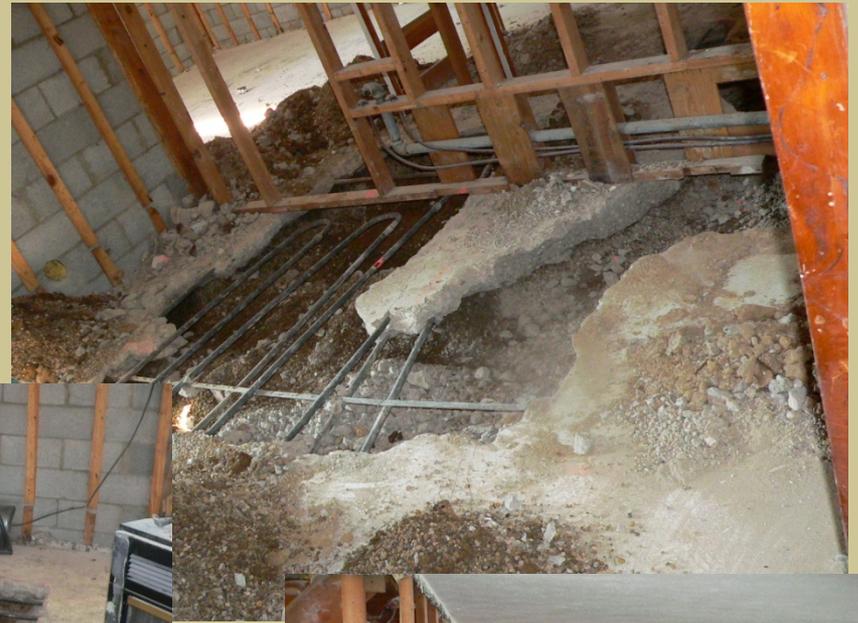
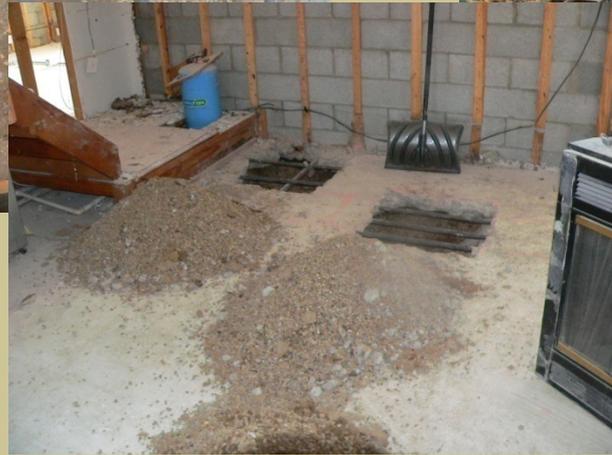
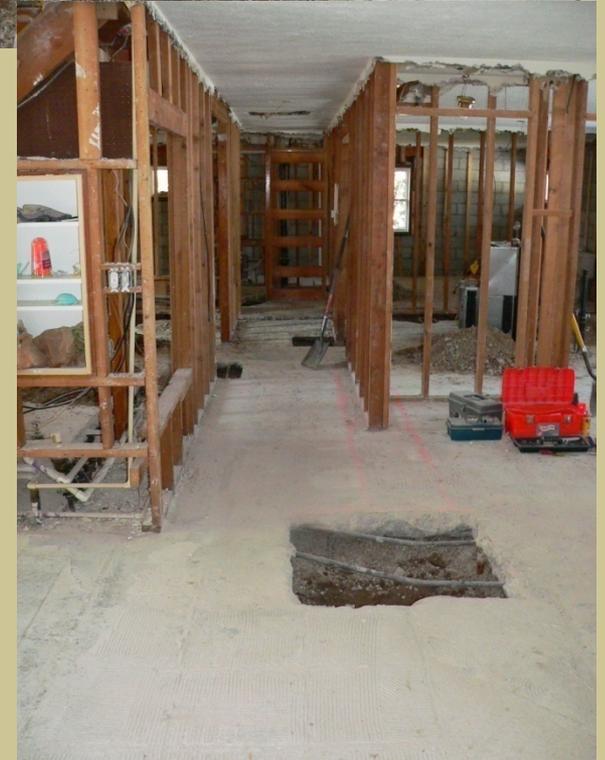
Thickened slabs had to be poured to carry the load of the second story. The geothermal pipes had to be worked around to establish these slabs and still maintain the integrity of the geothermal system.

All new underground plumbing was installed to replace the 50+ year old cast iron underground lines.

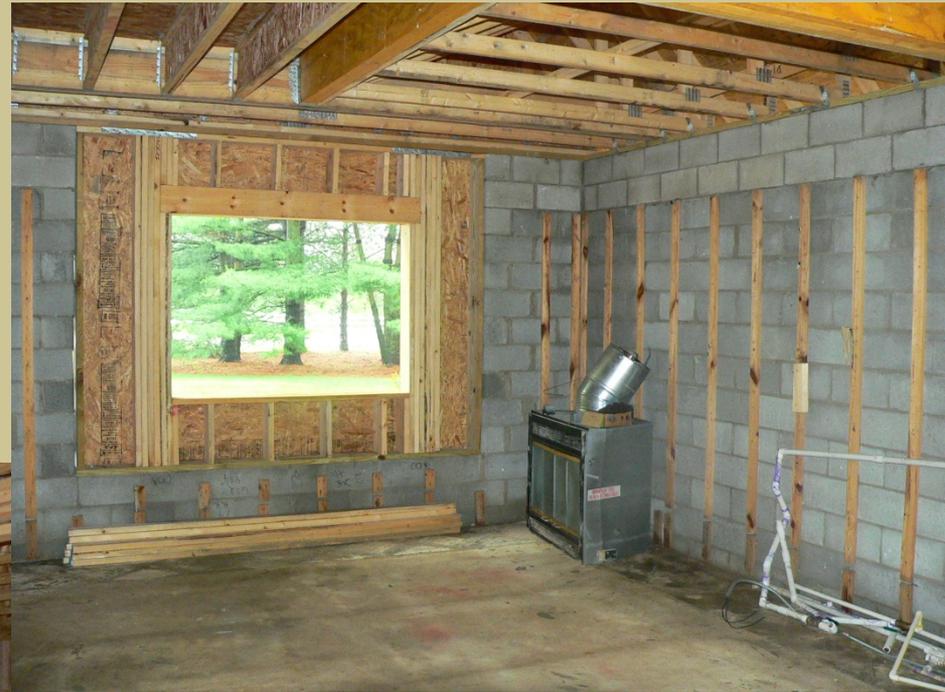
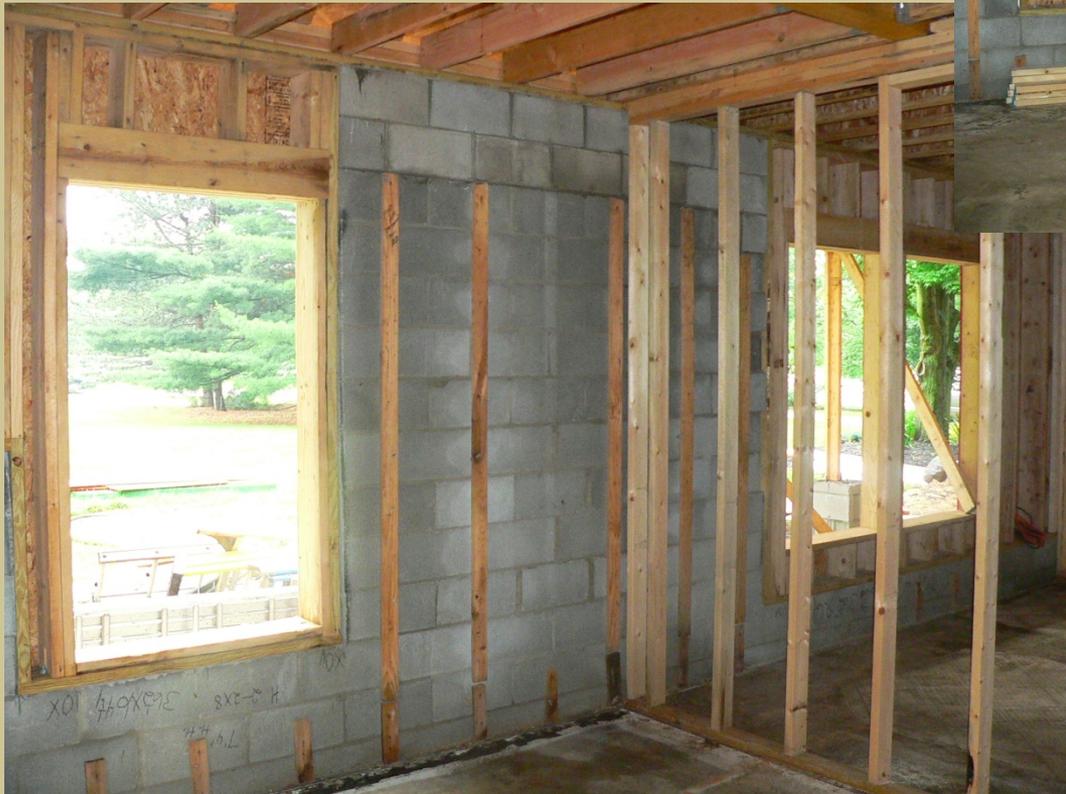
The addition of new window openings were challenging due the original block wall construction. Openings had to be saw cut to accommodate the new framing.

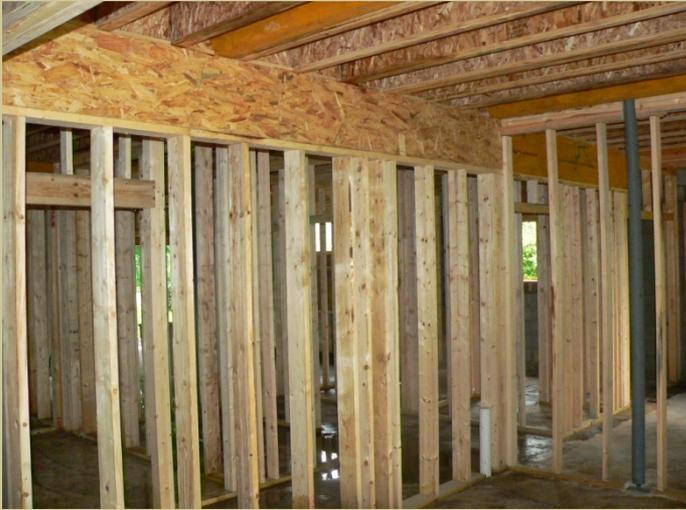
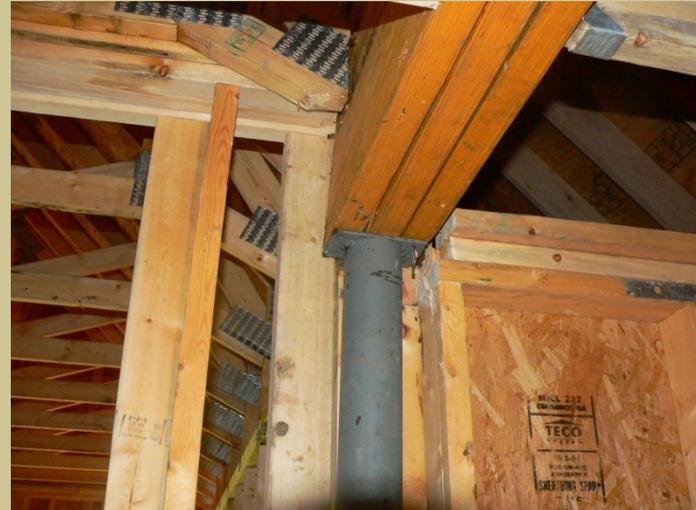
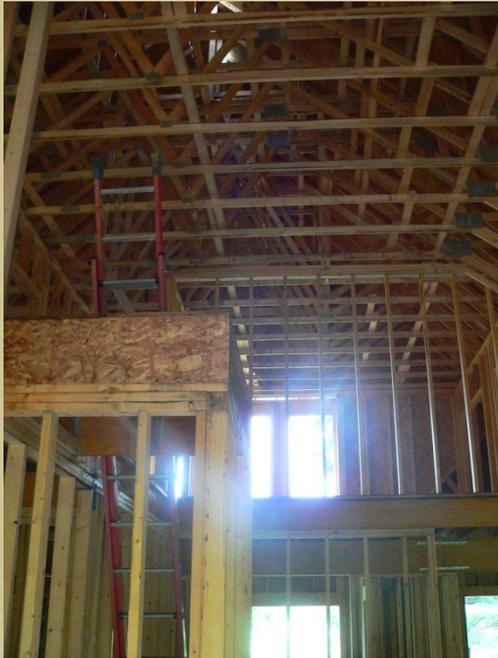
Steel reinforced columns were used to carry the second floor load on thickened slabs.

Flush and dropped beams throughout the entire first floor created challenges for locating HVAC and plumbing while minimizing the use of soffits.

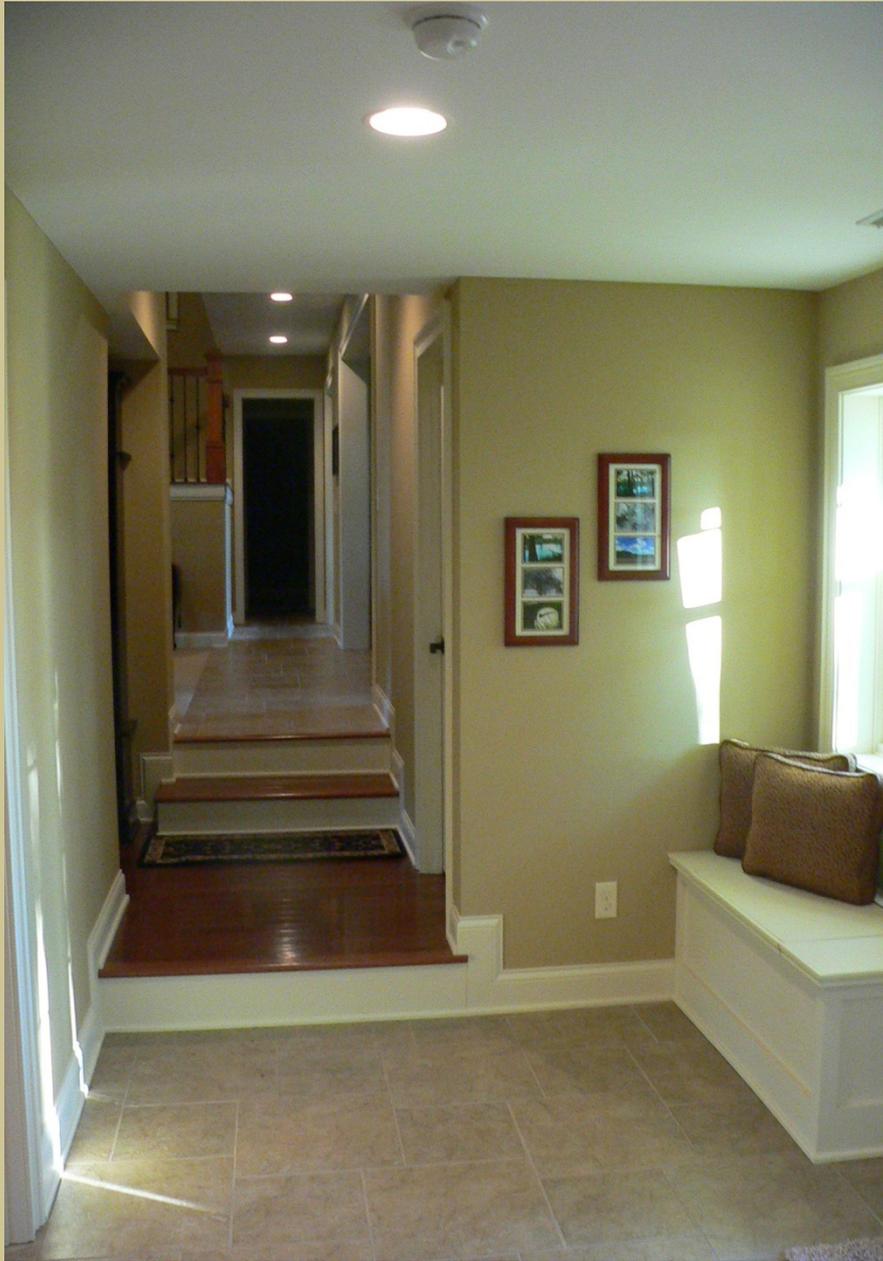
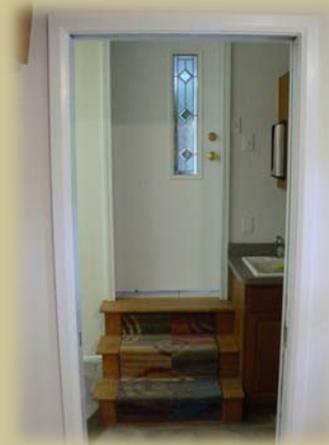
A landing was built to help with the new plumbing for the kitchen. The waste lines run under the landing floor to the ½ bath. The landing also helps with the transition from the mud room to the main living area.

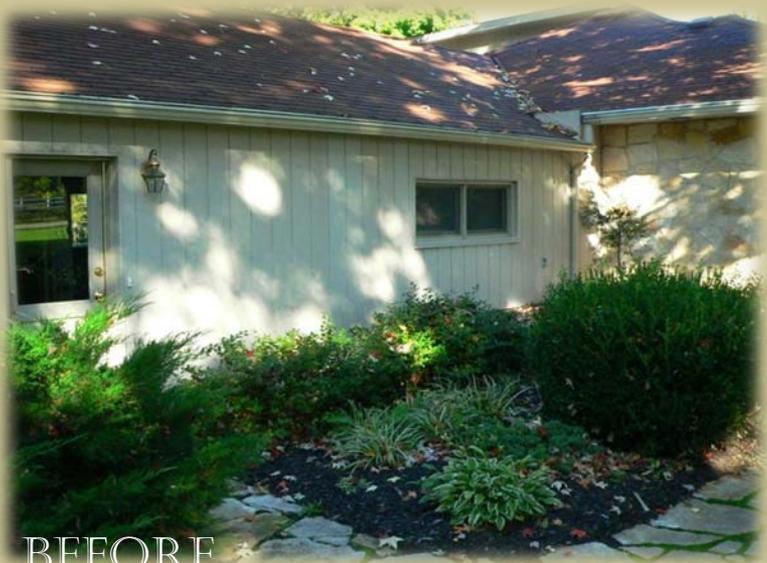
BEFORE

The side entrance was relocated to add balance to the front of the house, and allow for the new gable roof and pillars.

The old stone that was originally on the house was re-used to create a cobble stone walk to the side and front doors.

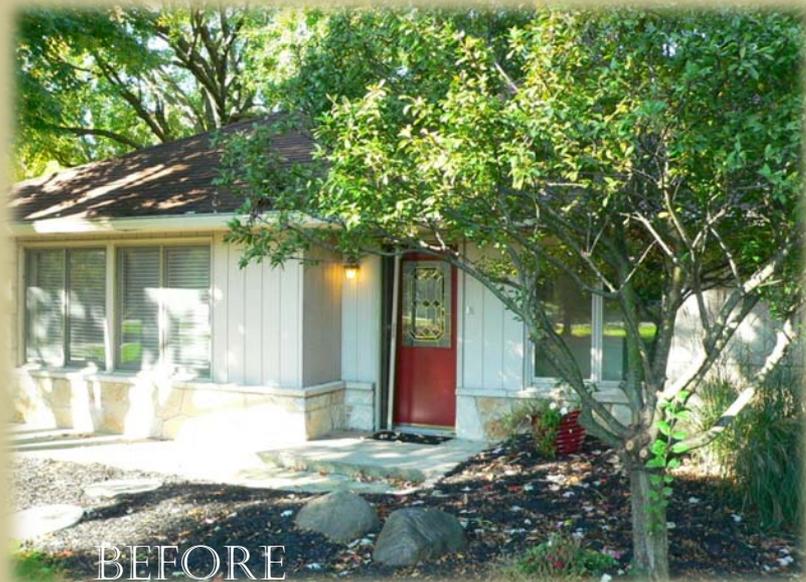
BEFORE

The new front porch features tapered and “keyed” columns with stone piers.
